33 PRESERVATION BRIEFS

The Preservation and Repair of Historic Stained and Leaded Glass

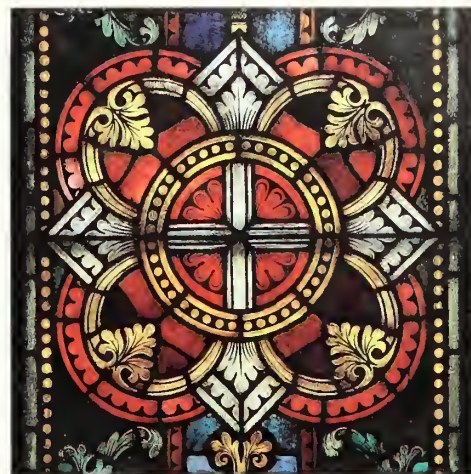
restoration work undertaken on stained and leaded glass must be done by professionals, whether the feature is a magnificent stained glass window or a clear, leaded glass storefront transom. Before undertaking any repair work, building owners or project managers should screen studios carefully, check references, inspect other projects, and require duplicate documentation of any work so that full records can be maintained. Consultants should be employed on major projects.

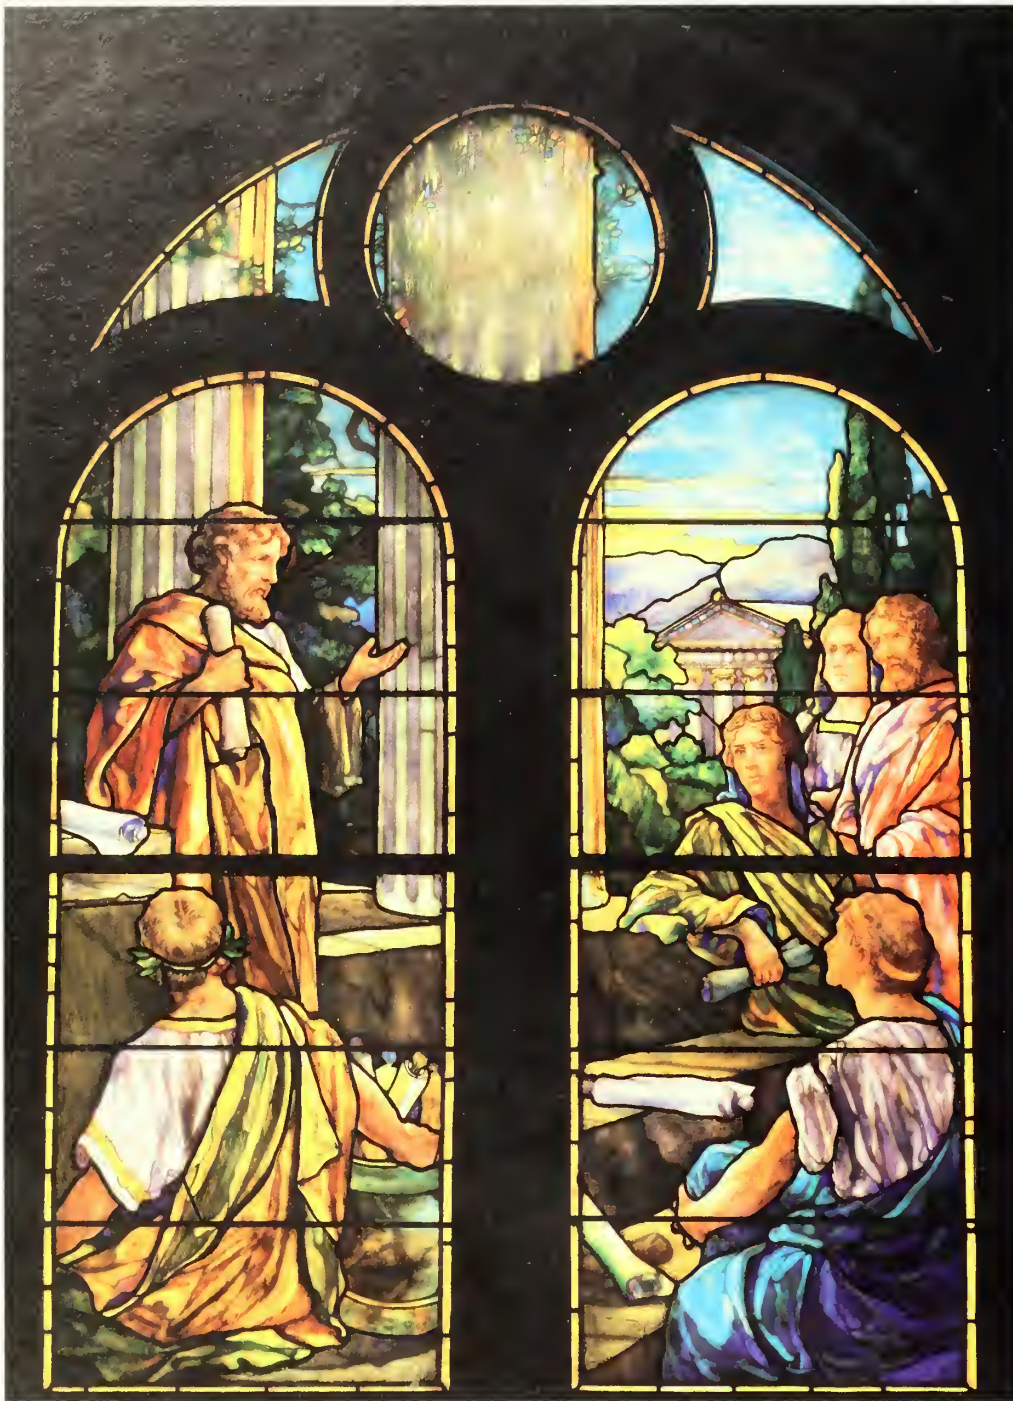
Figure 6. A 1907 window typical of those produced by Tiffany Studios. Characteristics include the use of opalescent glass, intricate leading, copper foil, extensive etching, plating (i.e., several layers of glass), and a scene with perspective that simulates a painting. Hyde Park Union Church, Chicago. Photo: Diana Kincaid.

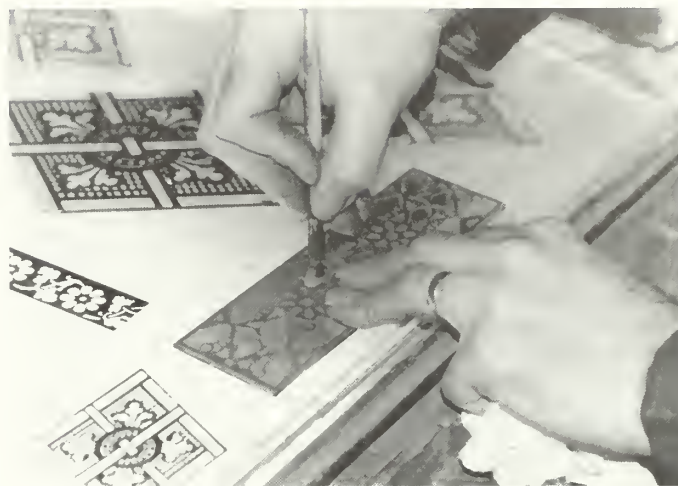
Figure 15. New stencils are used to produce matching replacement glass for repetitive stenciled patterns in a ca. 1870 window. Photo: Neal A. Vogel.

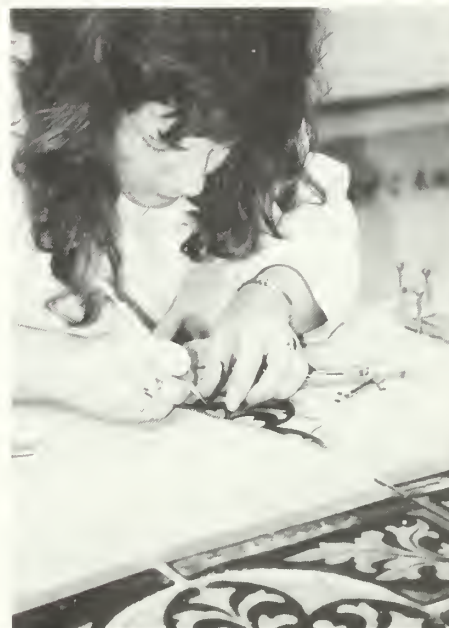
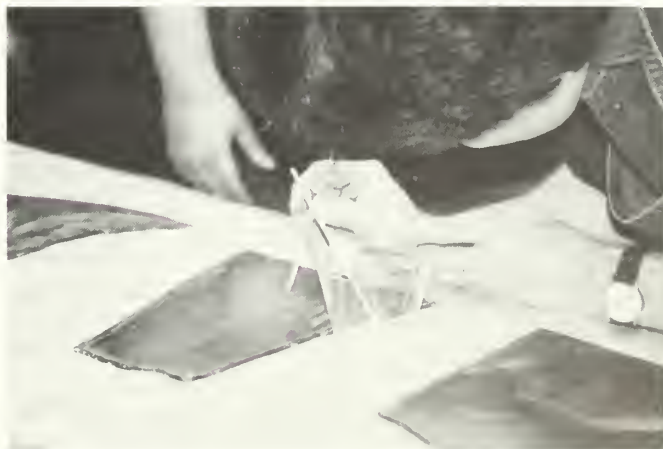
Figure 17. A valuable piece of flashed glass is carefully edge-glued with epoxy and a steady hand. Photo: Neal A. Vogel.
